Asbestos Survey and Limited Lead Paint Inspection

Five Structures

Grandview Lumber Property

June 2019

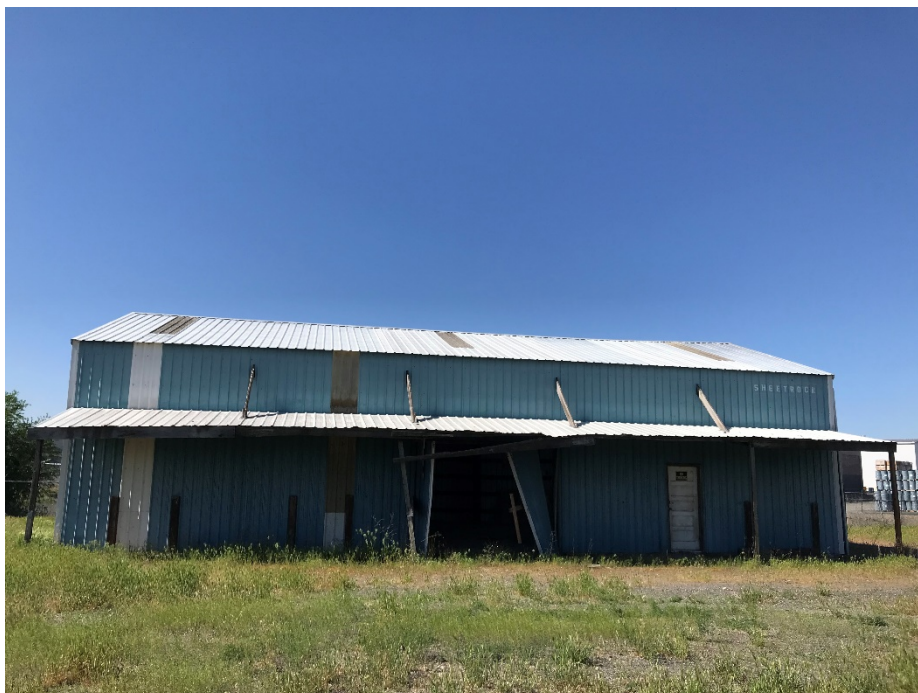
Photo 1. Building #1, view from north of building.

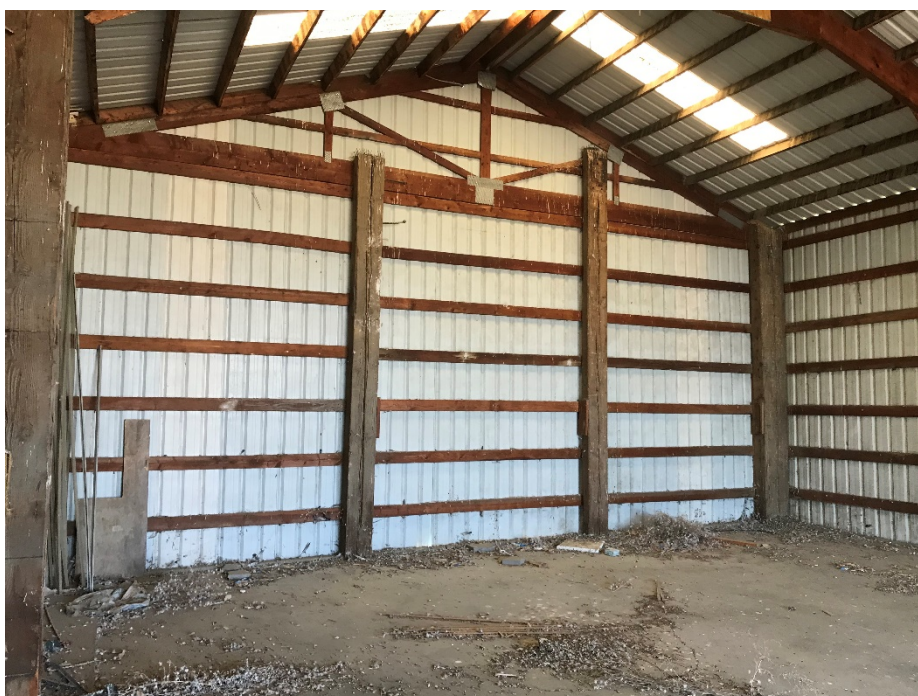
Photo 2. Building #1, view of interior west side of building.

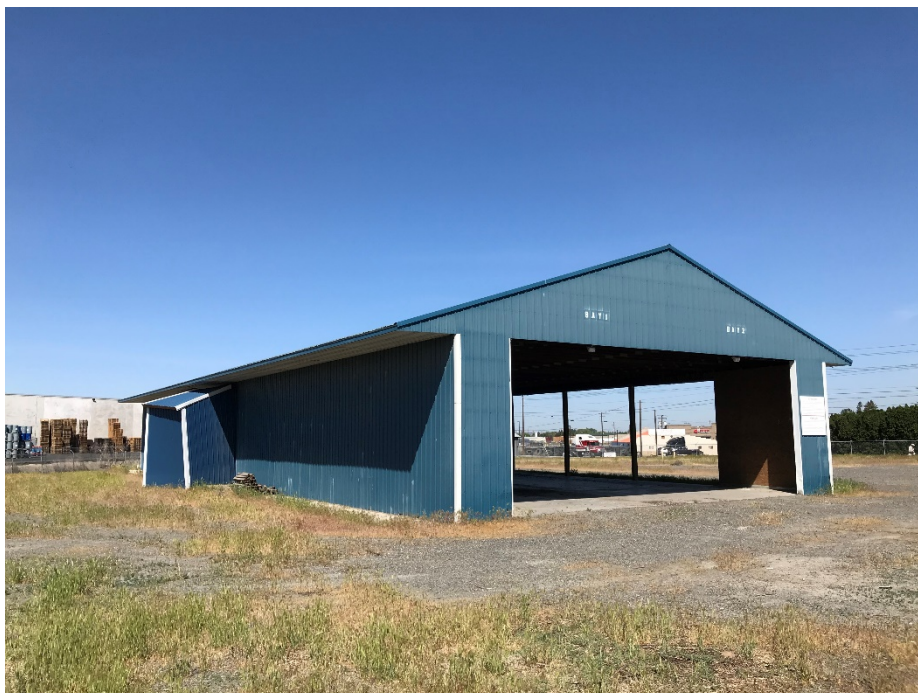
Photo 3. Building #2, view from southeast of building.

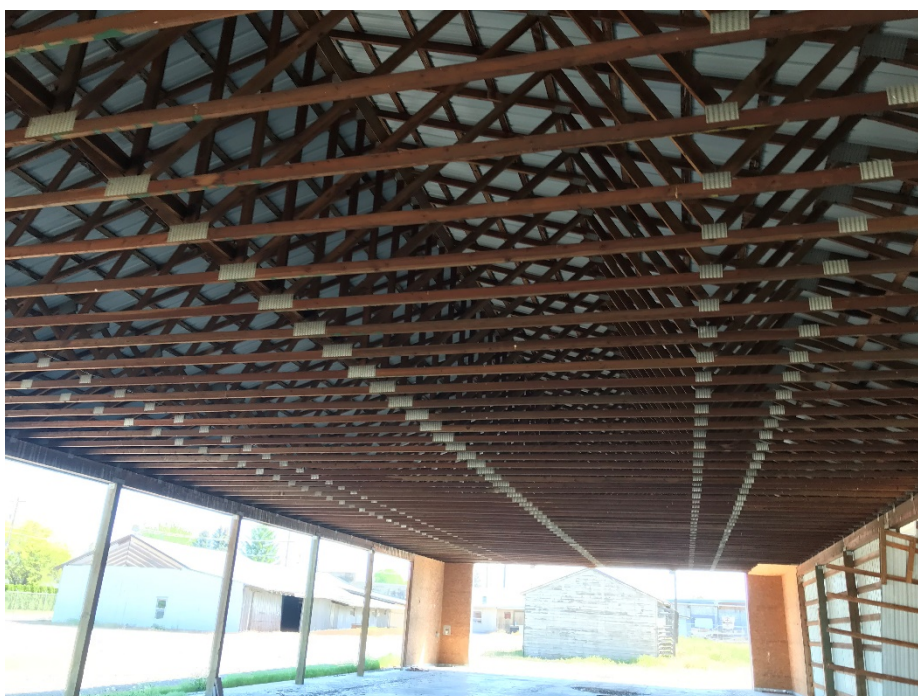
Photo 4. Building #2, view from east side of building showing interior.

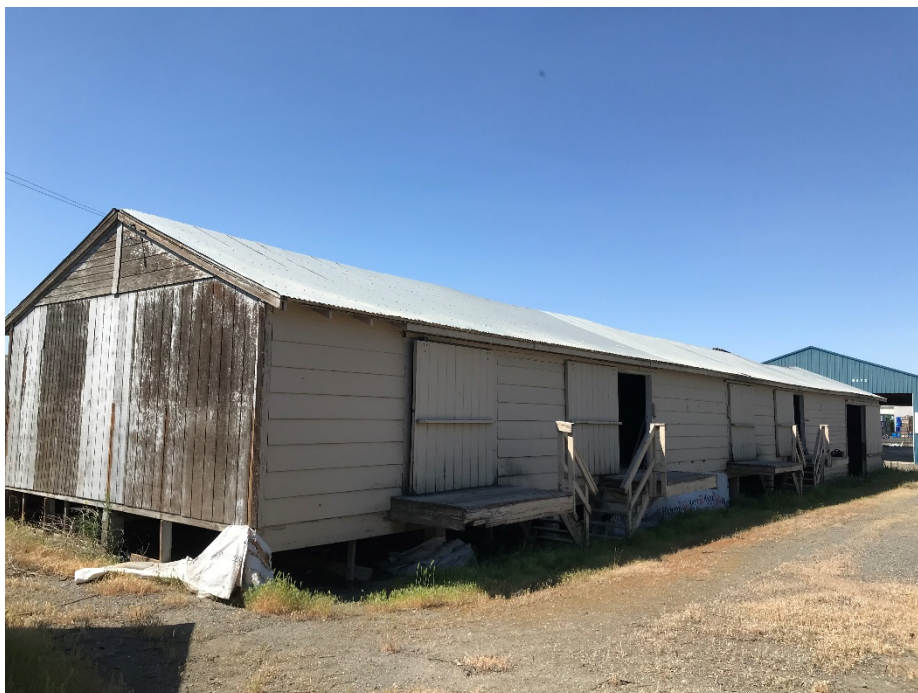
Photo 5. Building #3, view from northeast side of building.

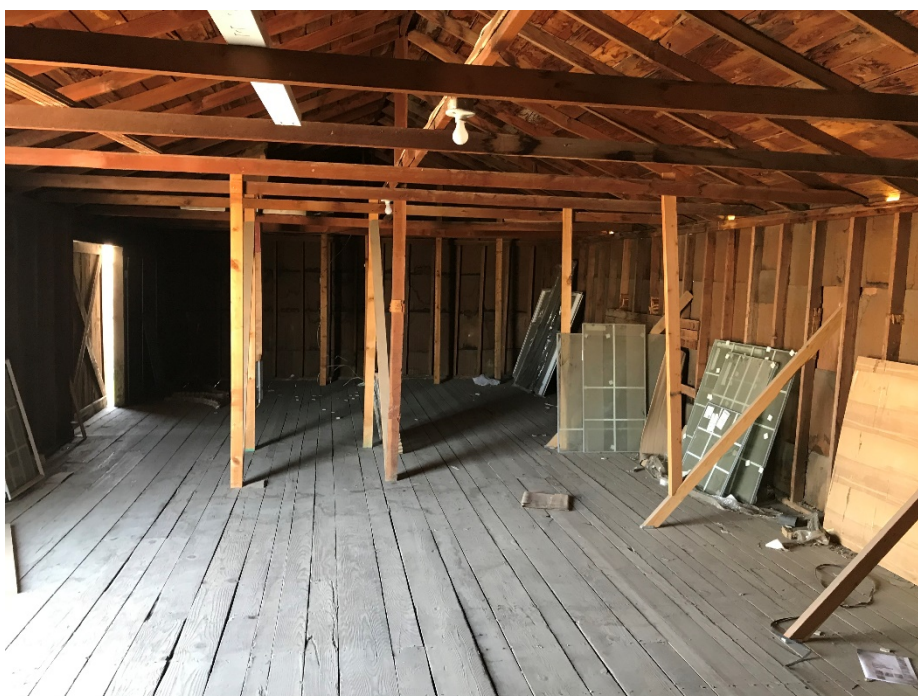
Photo 6. Building #3, view of west interior of building.

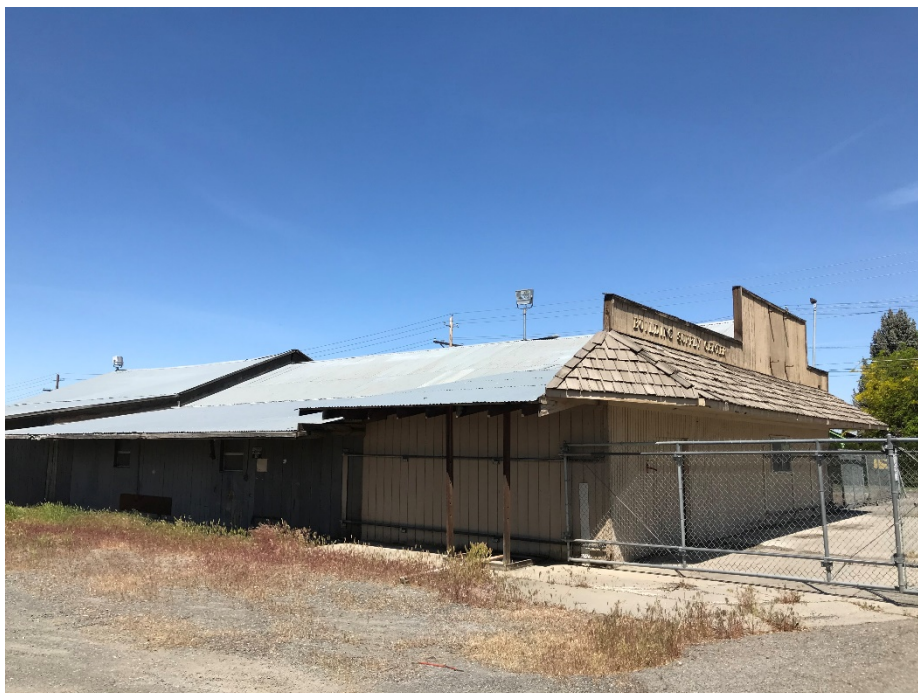
Photo 7. Building #4, view from southeast showing west end of building.

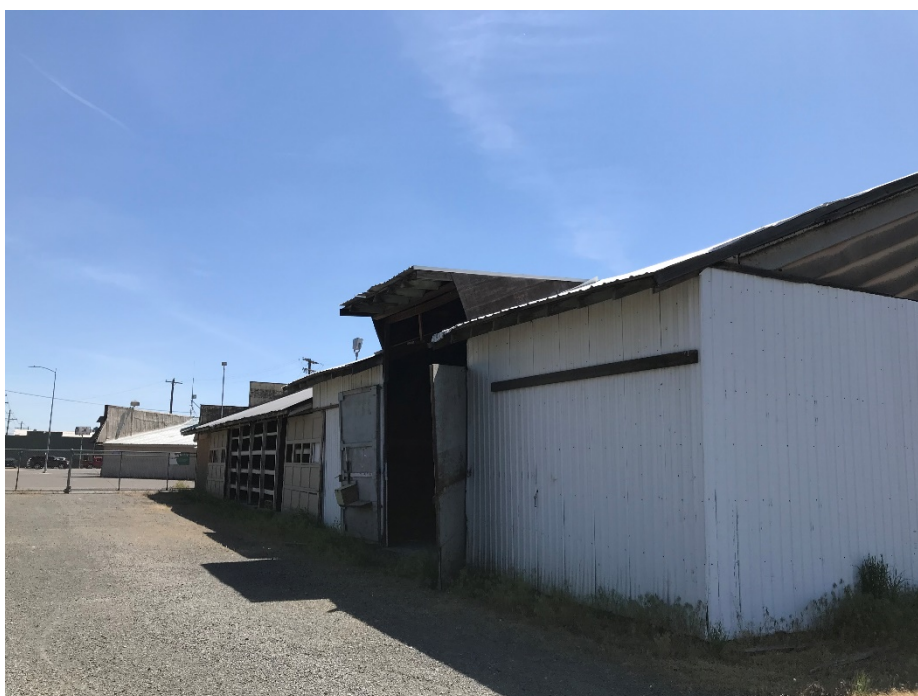
Photo 8. Building #4, view from northwest showing north side of building.

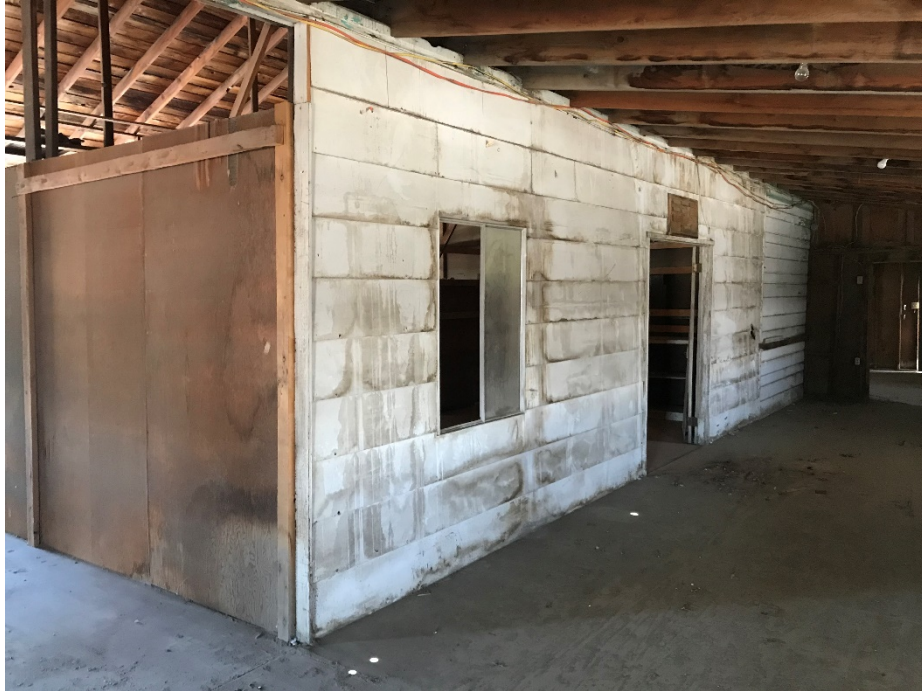
Photo 9. Building #4, showing south side of original structure on east end of building.

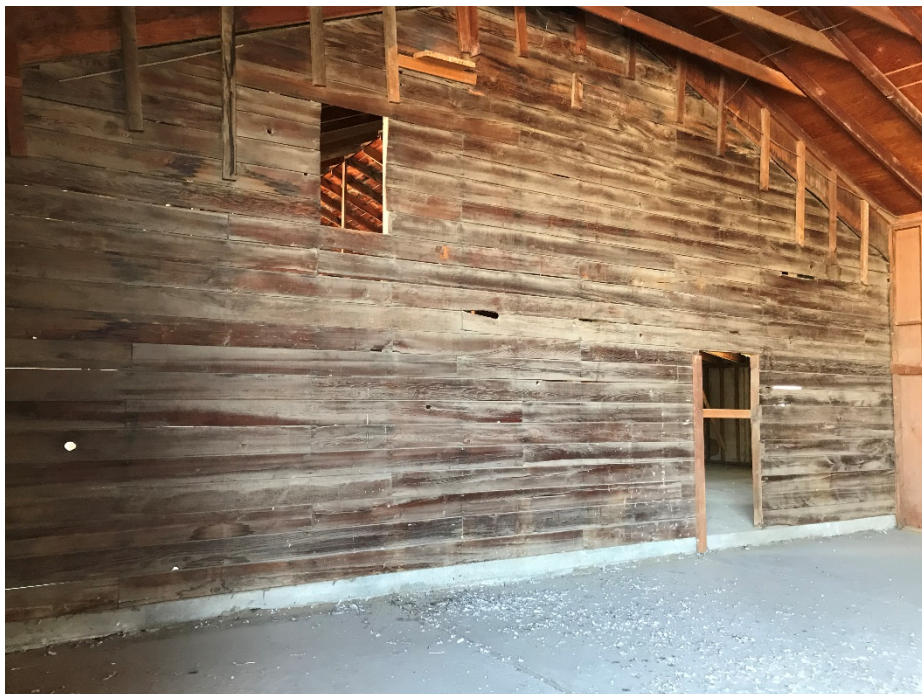
Photo 10. Building #4, view from inside west bay showing east wall of another (second) addition to the original building in Photo 9 above.

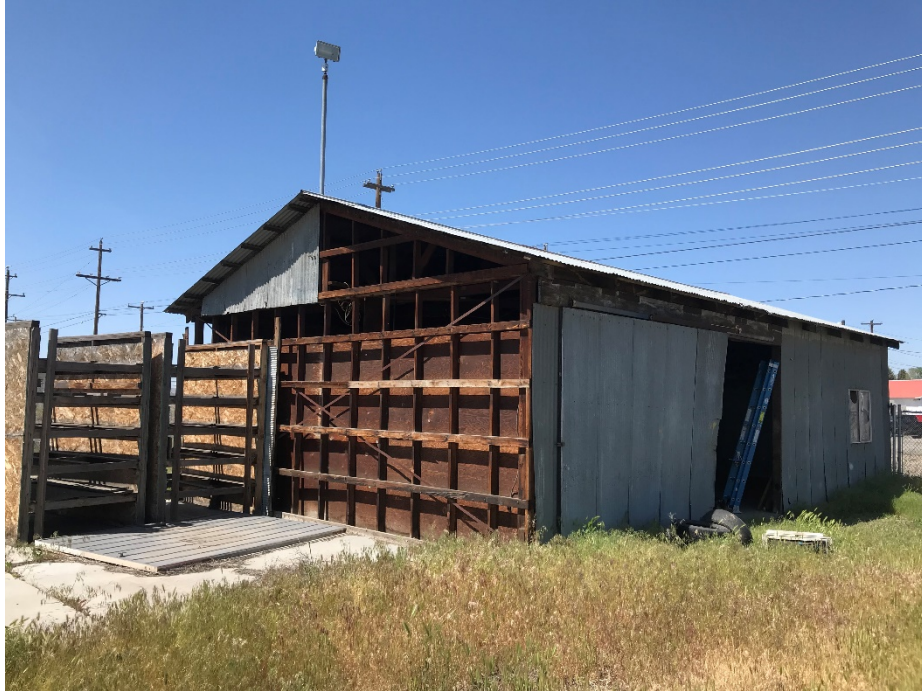
Photo 11. Building #5, view from southeast of building.

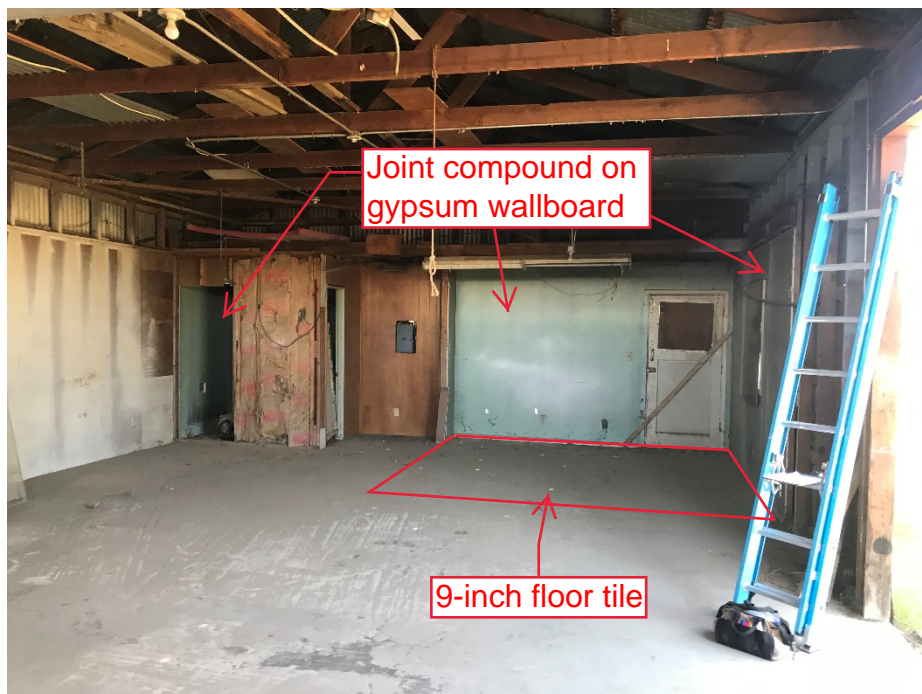
- Joint compound on gypsum wallboard assemblies – 2% asbestos was identified in the joint compound layers on the remaining gypsum wallboard walls on the north side of Building #5. This material is damaged along edges where sections of the walls were previously removed. The joint compound would be considered friable during demolition and renovation work. Additional analysis may be performed which could result in the total asbestos concentration of the wallboard system in being less than one percent (<1%) asbestos. See the regulatory conversation below for additional information.
- Asbestos-containing vinyl floor tile was observed in the northeast area of the building. The black mastic under the floor tile contains <1% asbestos. The tile is significantly damaged along the edges of the section of flooring. It is possible that dust from the floor tile has been spread throughout the building.

Photo 12. Building #5, view of north interior showing gypsum wallboard with asbestos-containing joint compound and area of asbestos-containing 9-inch vinyl floor tile.

WAC 296-62-077 requires proper removal and handling of ACM by licensed and trained asbestos abatement contractors prior to building renovation or demolition.
